FINAL DESIGN REPORT / ENVIRONMENTAL IMPACT STATEMENT

Appendix L – Bridge Information

Highway Project
P.I.N. 1721.51
BINs: 1033141 / 1033142
Interstate 87 (I-87) Exit 4 Access
Improvements
Albany County

BIN 1033141

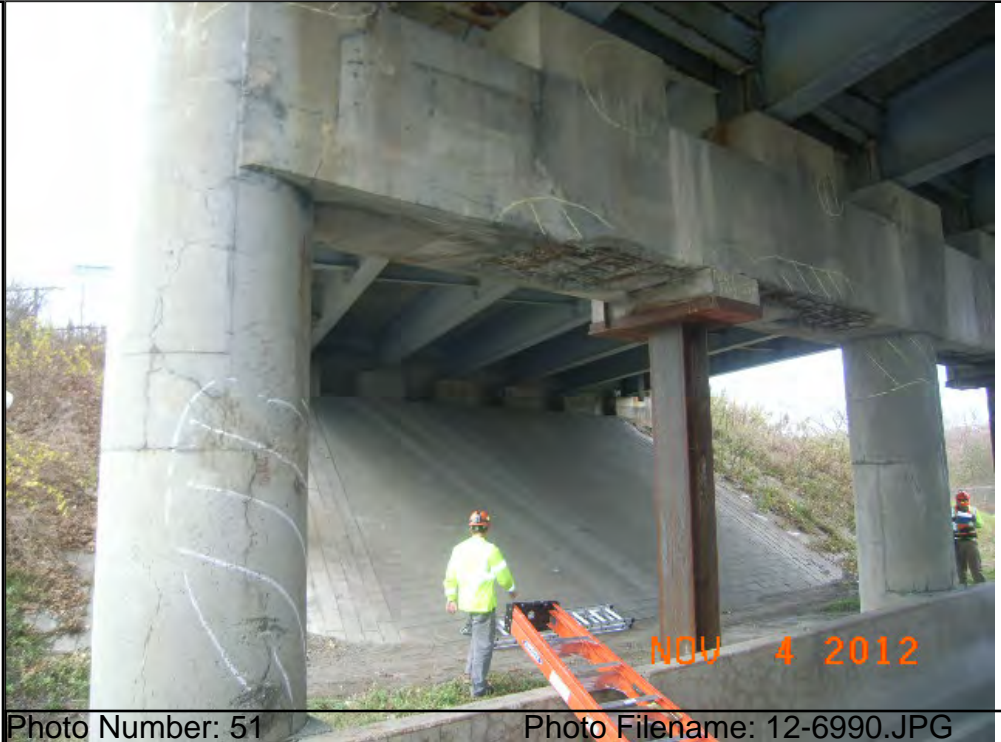
Photo Number: 51

Pier - Columns - Pier 1 -
End face of right half

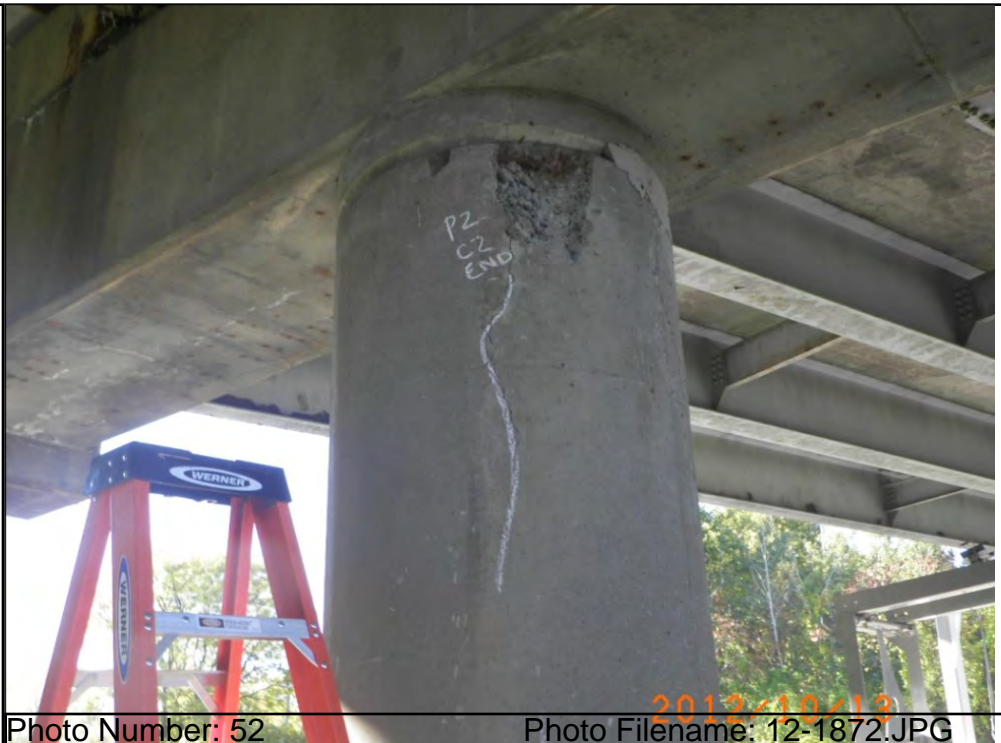
Photo Number: 52

Pier 2 - Columns - Col 2
- End Top Left

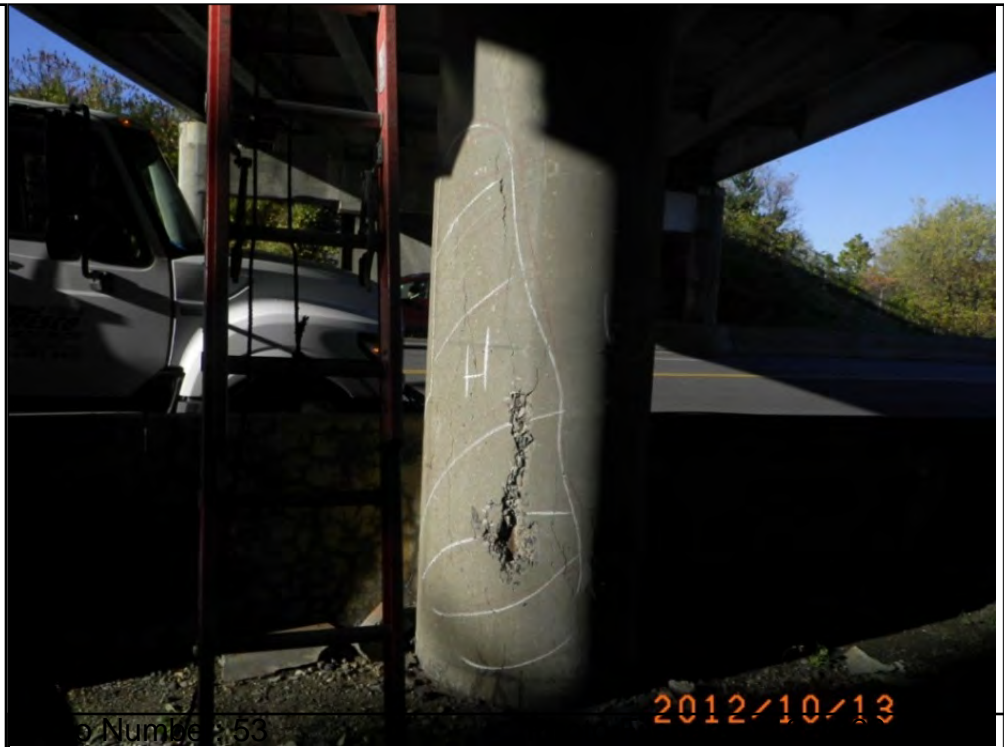
Pier 2 - Columns - Col 2
- End Right near bottom

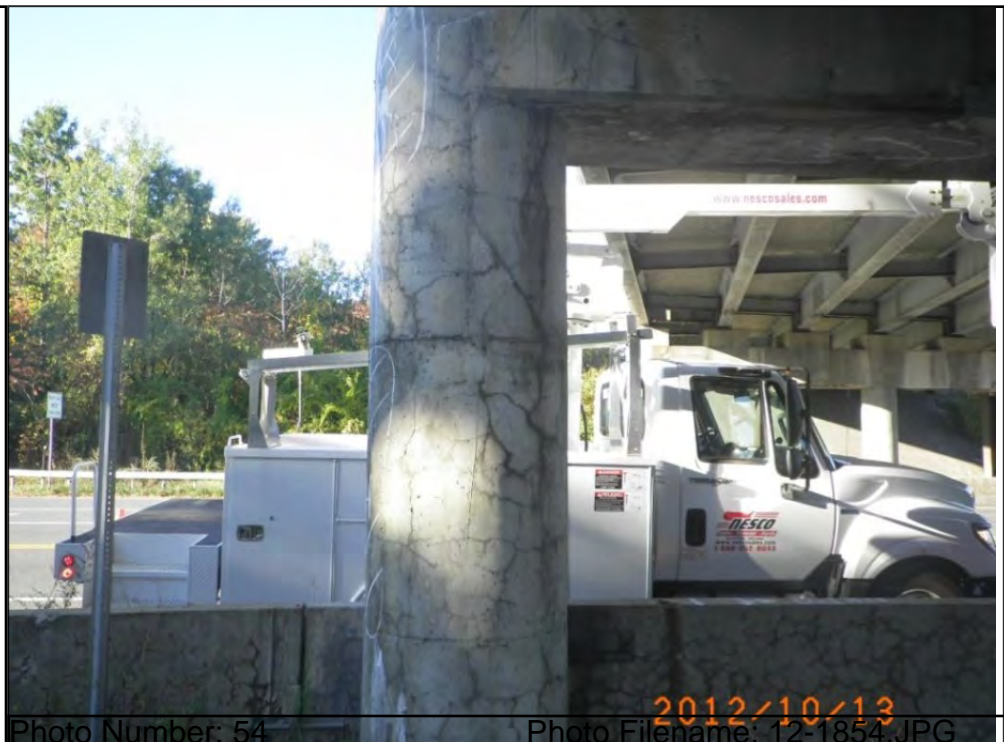
Pier 2 - Column 3 End
Face

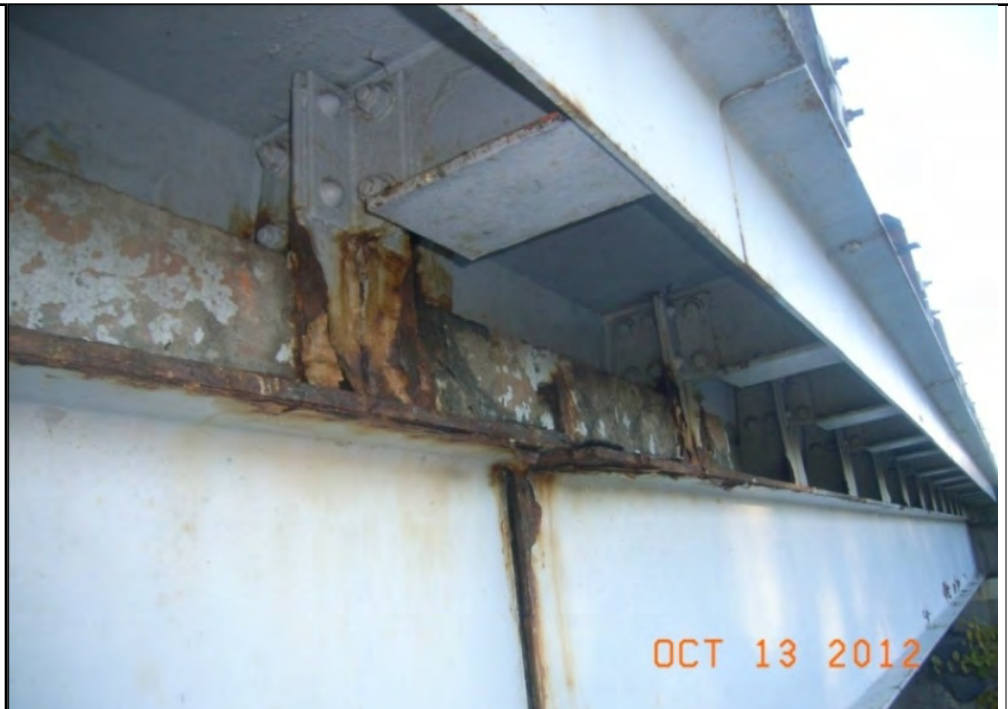
Photo Number: 55

Deck Elements -
Railings - underside
overview of bridge rail
support system - Right
side at Pier 2
looking towards End

In all 3 spans the bridge rail post anchorage is bolted through a steel plate support structure. Under the rail post base plate there is a build-up of pack rust. This pack rust is causing the single outboard anchor bolt to break off at the nut. There are a total of 3 anchor bolts; therefore, a loss of 33% of the anchorage. The bolts remain in place only by rust and friction with a potential for the bolts in Span 2 to fall out onto live traffic. This flag follows a Safety Flag issued in 2011 for similar findings - this inspection encountered some additional locations.

Analytical review of deteriorated br. rail support system.

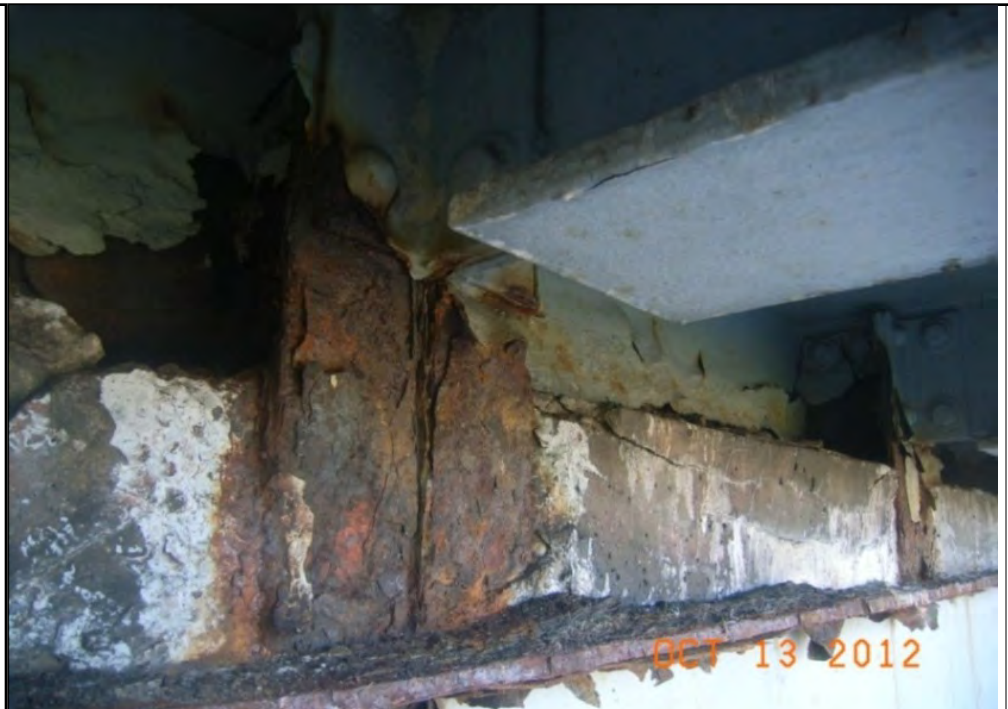
Photo Number: 56

Deck Elements -
Railings - underside of
bridge rail support system
- Left side near end of
Span 2

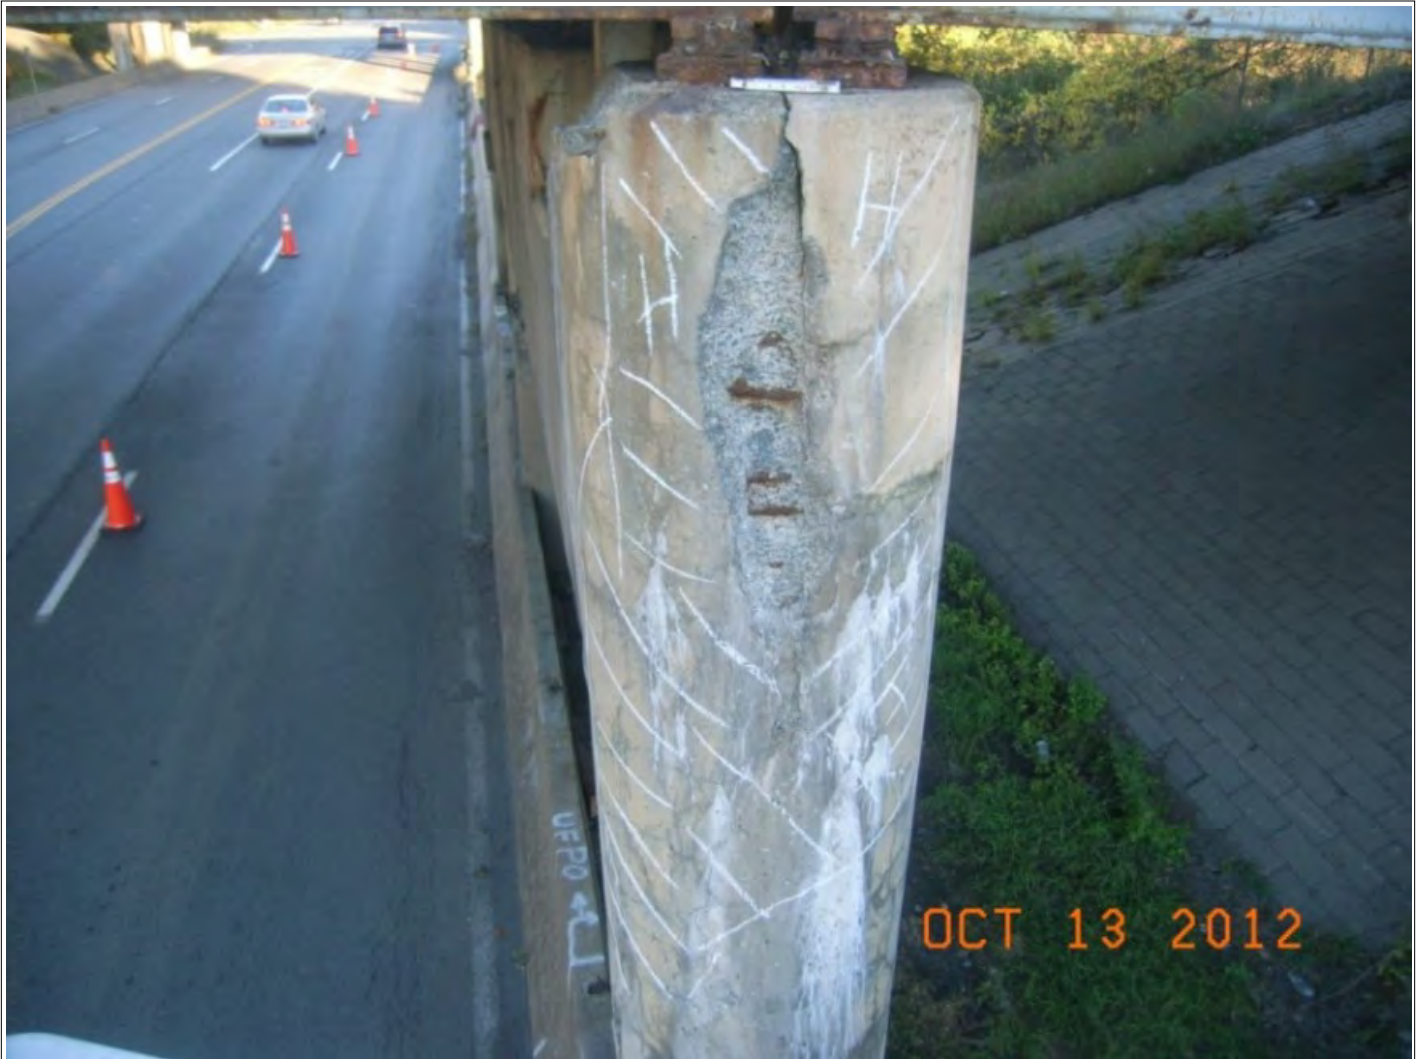
12-5620.JPG - Attached to Yellow Flag 1P120026

YELLOW Structural Flag 1P120026. Deteriorated & Cracked pedestal.

At Pier 2, the Pedestal for G7 (Right Fascia) has a 3/8" wide crack on the Right side emanating from under the Span 3 bearing masonry plate. This crack extends down the Right face 2 ft to a hairline crack into a spall of soft crumbling concrete. The crack is also visible emanating from the Left side of the Span 3 bearing and extends down the End Left corner 16" terminating at the top of cap beam. There is minor spalling and cracking on both Left and End faces at the corner. The primary crack on the Right face of the pedestal is along a cold joint of an older repair; reference the 2004 inspection Photo 9.

Pier 2, Rt Face Ped 7 - overview

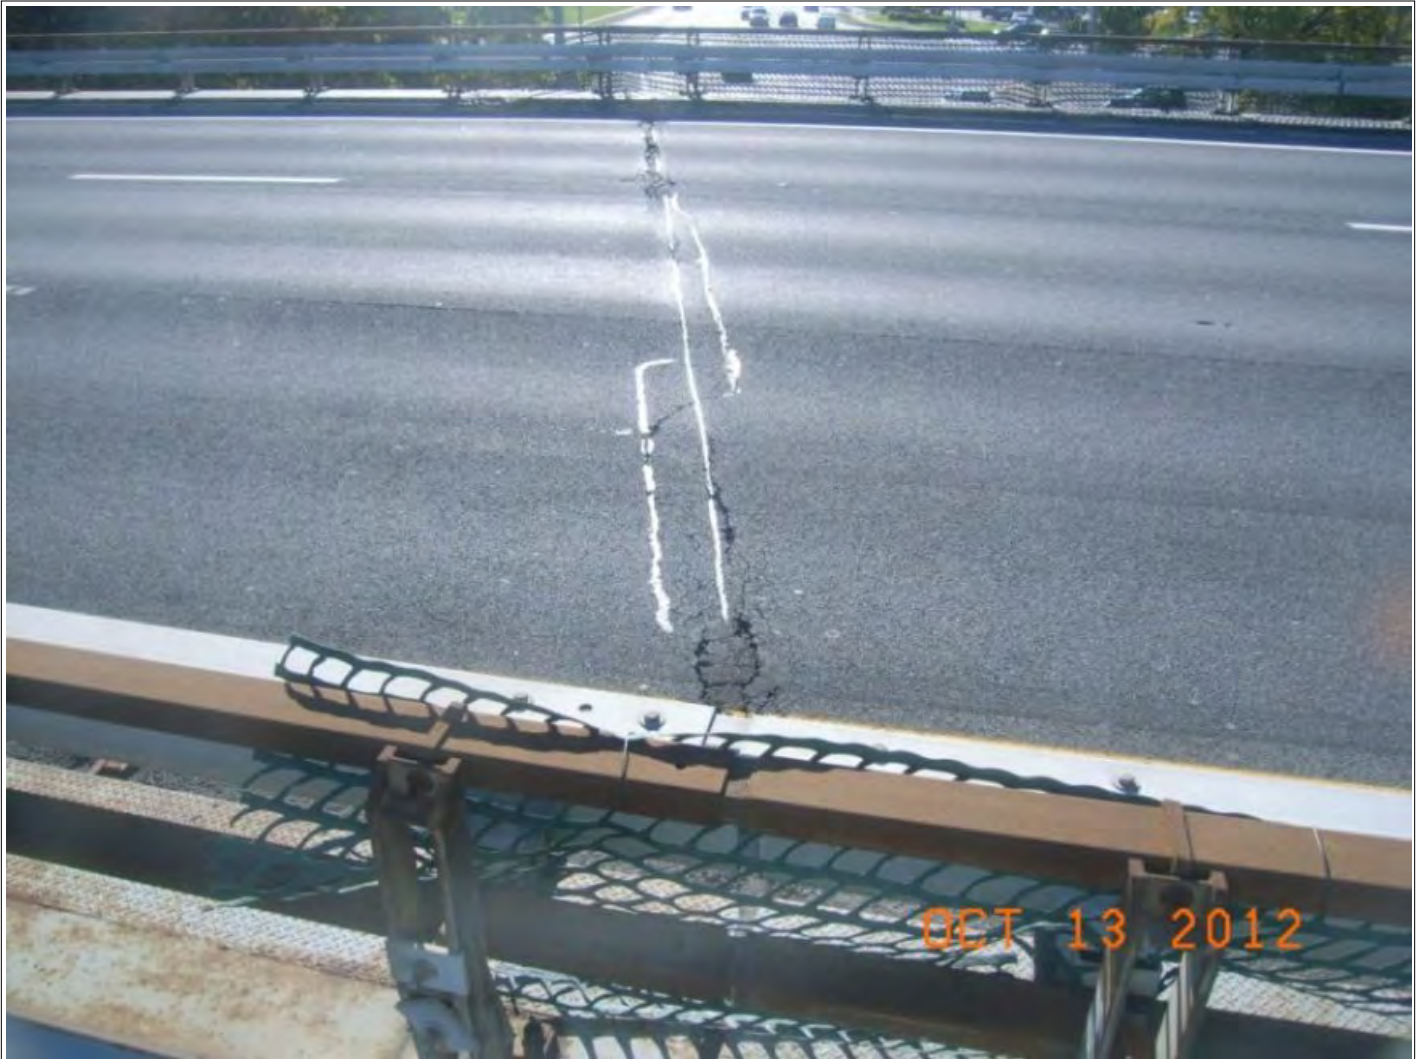
12-5668.JPG - Attached to Safety Flag 1P120027

Overview of bridge rail across top of deck at Pier 2

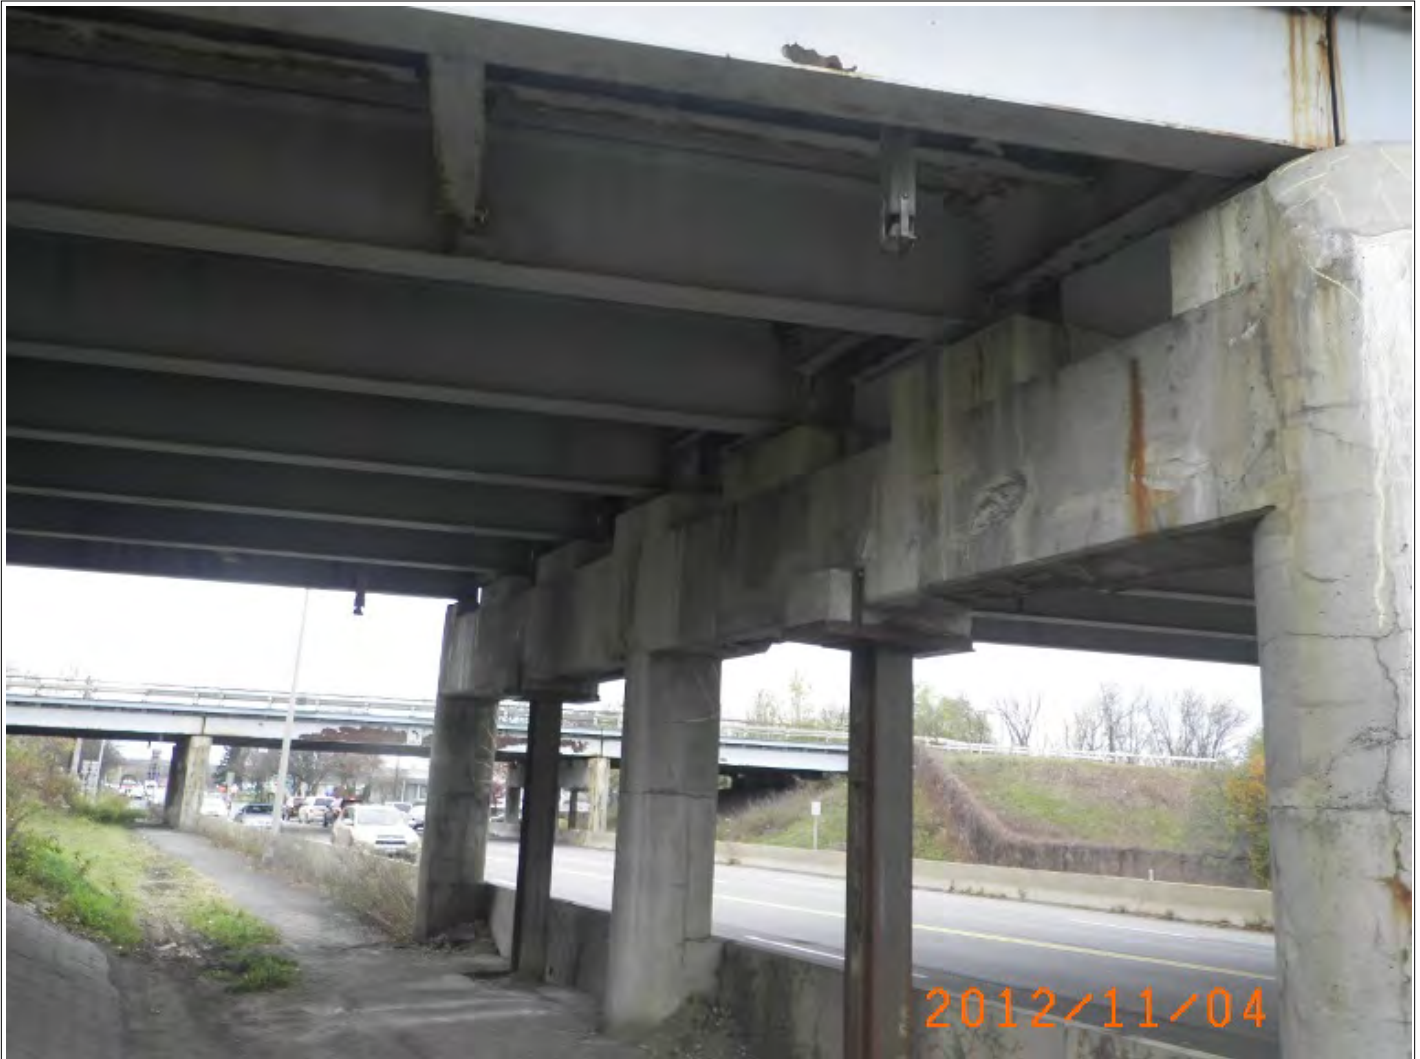
12-2895.JPG - Attached to Yellow Flag 1P120028

The concrete pier structure supports seven girders with a continuous cap beam over three circular columns. In response to deterioration of the cap beam and columns, initially cited in Yellow Flag 1U10031, temporary repairs were performed in 2011 by the installation of steel columns under the midspan of both cap beam bays. Those at Pier 1 are surrounded by soil - it is unknown if they extend to the top of the original continuous strip footing - the columns cannot be shifted - the amount of load they may be supporting is unknown.

Overview - Begin face from Right

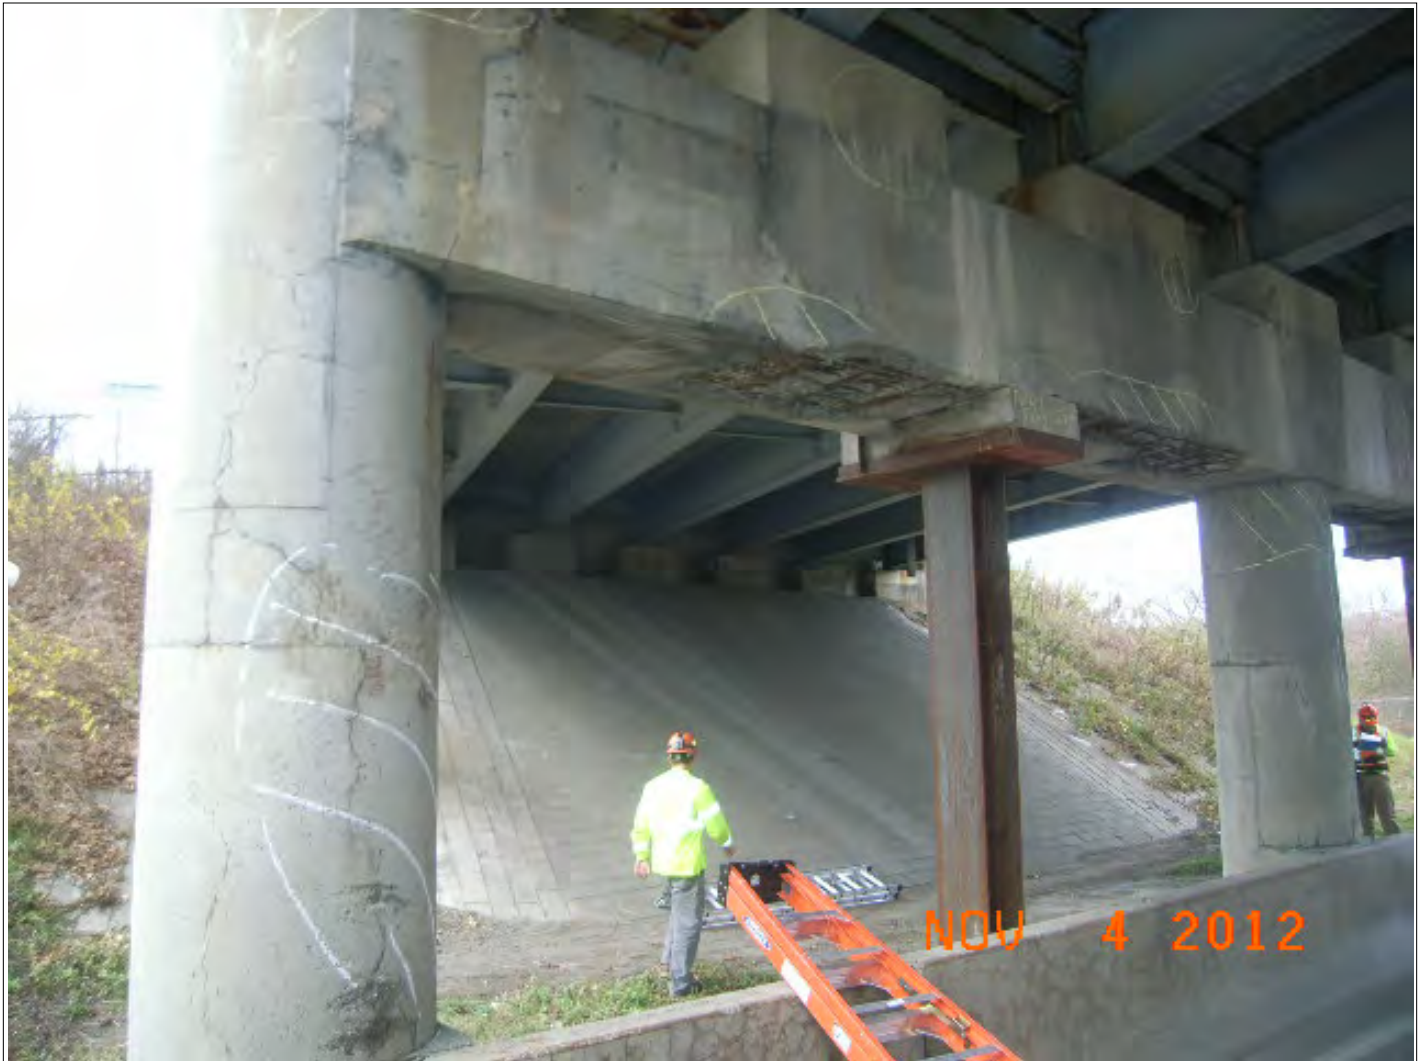
12-6990.JPG - Attached to Yellow Flag 1P120028

Overview - End face - Right portion of pier

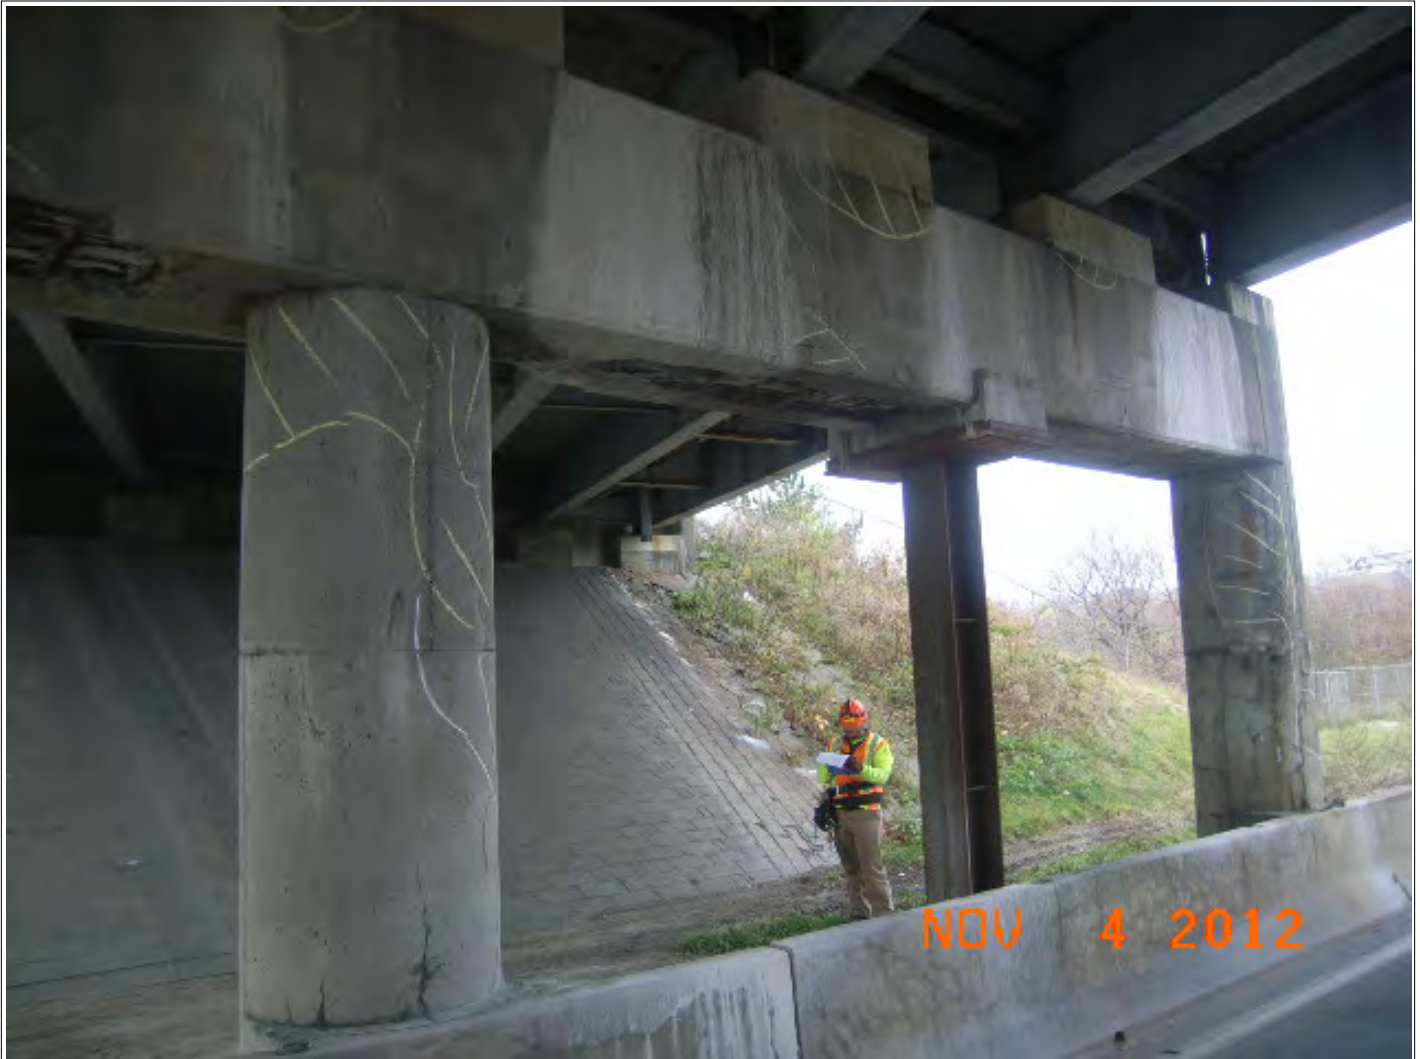
12-6991.JPG - Attached to Yellow Flag 1P120028

Overview - End face - Left portion of pier

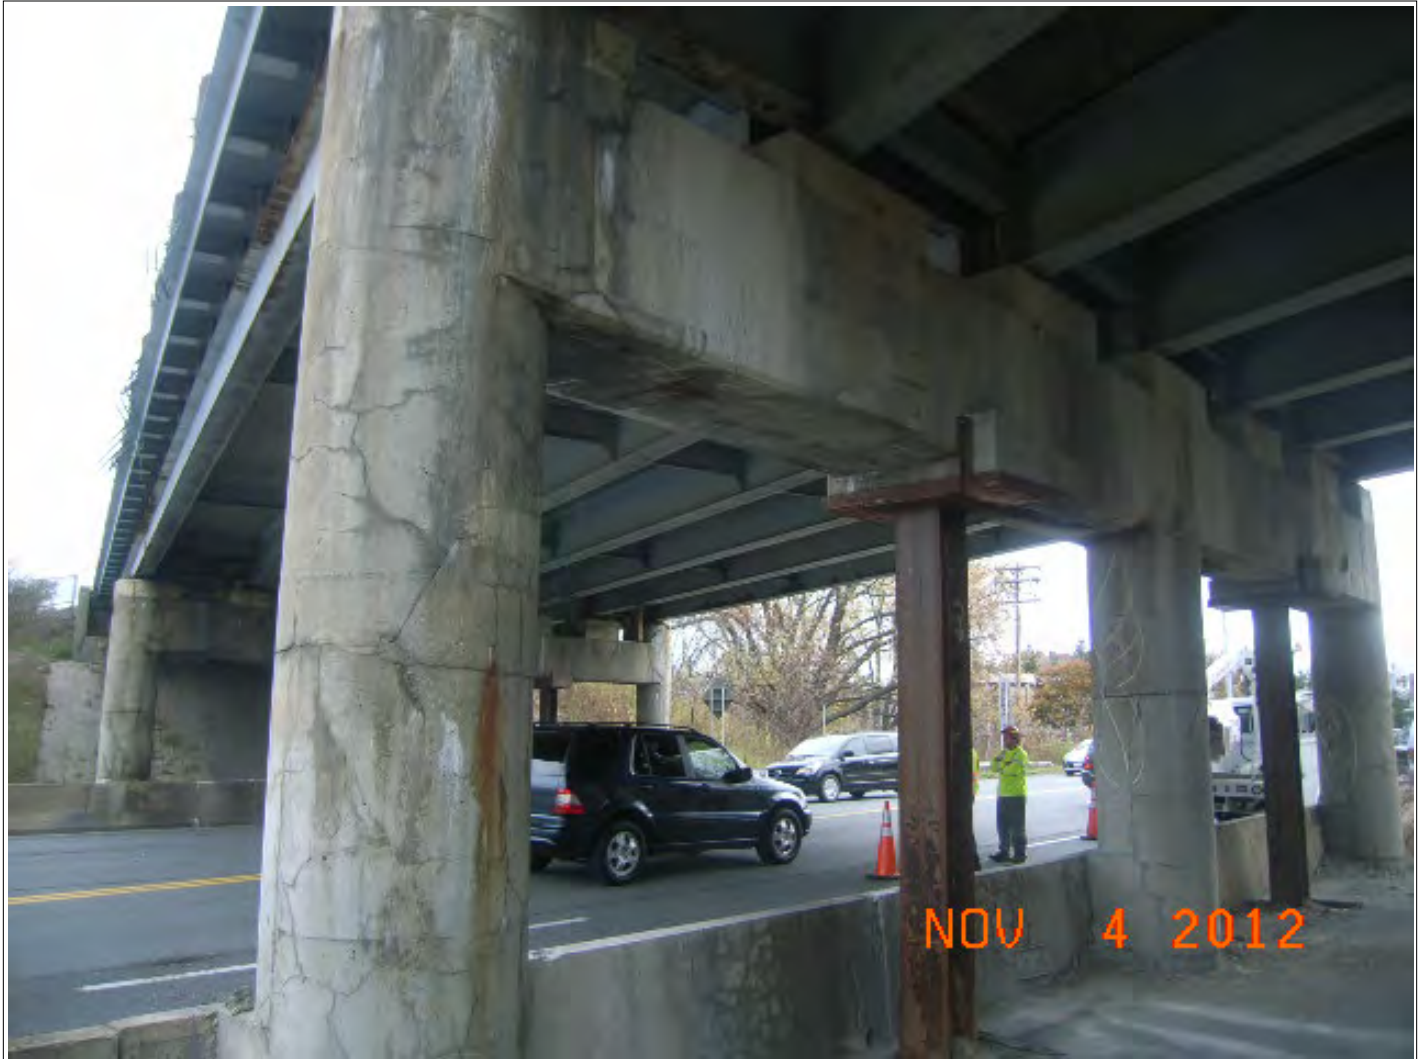
12-7008.JPG - Attached to Yellow Flag 1P120028

Overview - Begin face from Left
